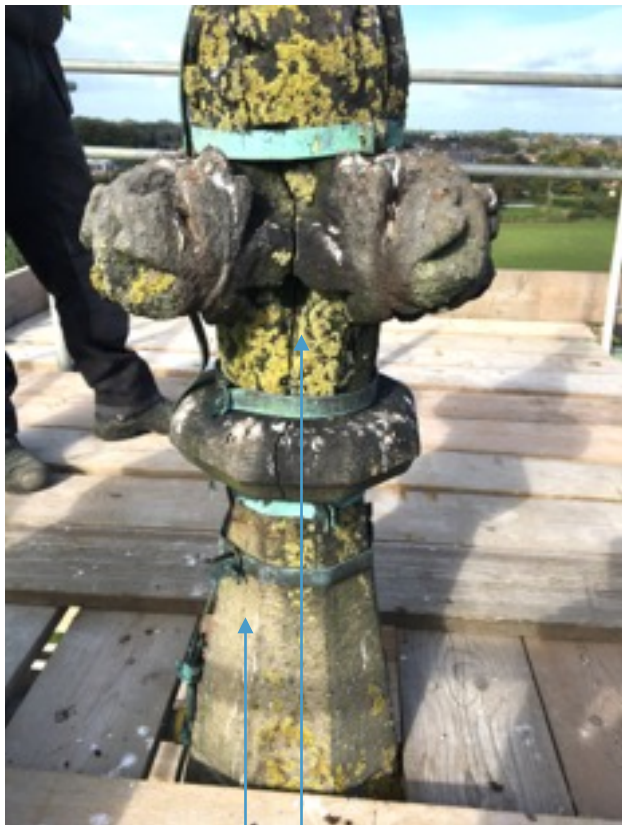
Vertical cracks through the top two pinnacle stones

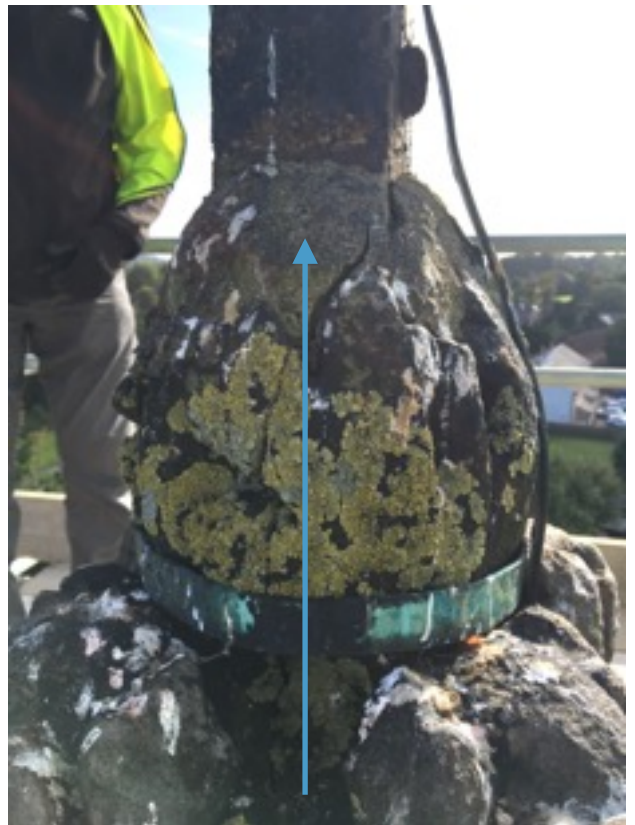
Concrete fill to the base of the iron cross

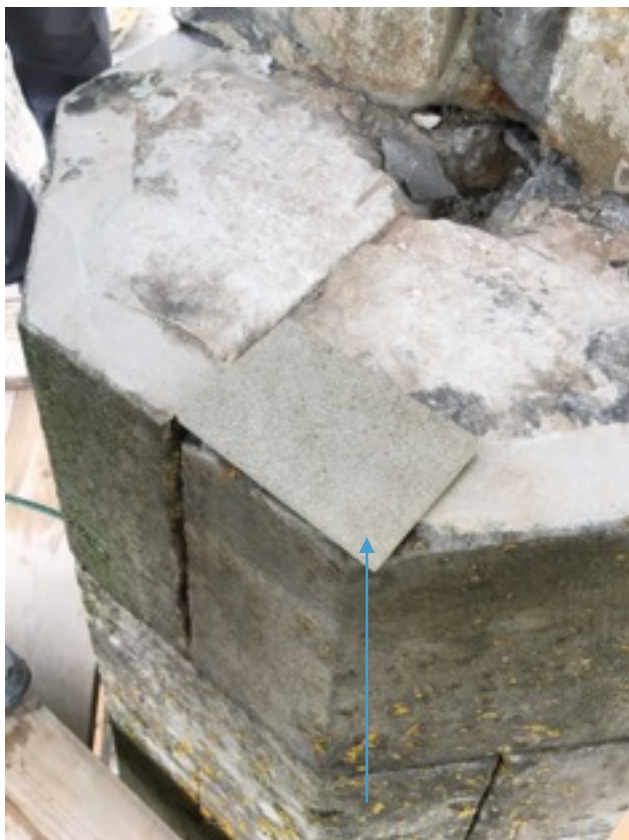
Base of the corroded iron rod ended in a pocket 5 courses below the cross. Sample of Crosland Hill sandstone, (grey/ buff ) adjacent to face stonework.

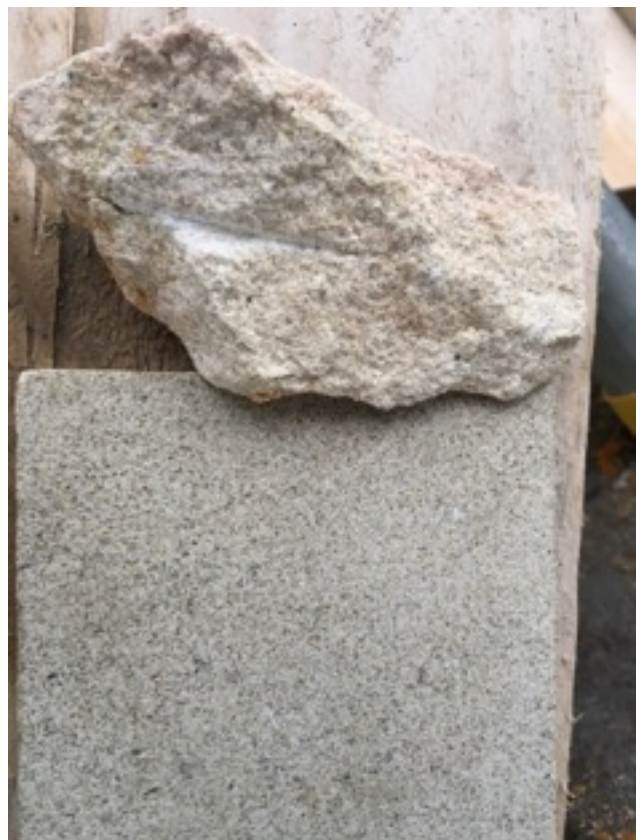
Sample of Crosland Hill sandstone, (grey/ buff ) adjacent to piece of freshly broken existing stone
